Manhole Inspection Summary

Manhole # S29KK_052MH

Location Address: **1758 NORTH AVE**

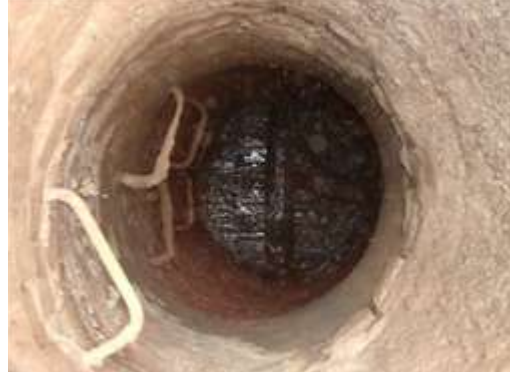
Top View

Corroded and missing steps.

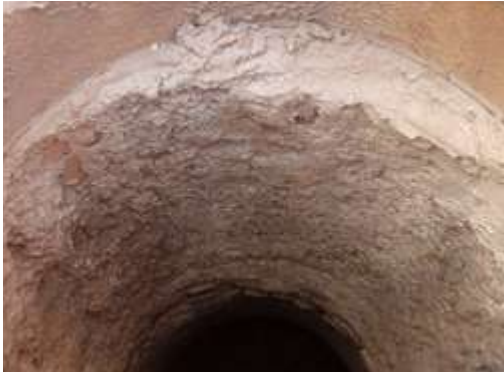
Defect

Frame leaks. Adjustment and Corbel infiltration.

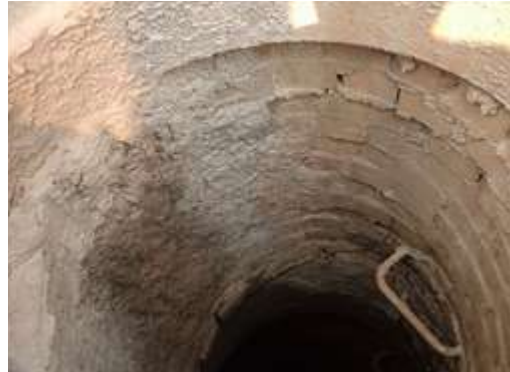
Defect

Frame leaks. Adjustment and Corbel deterioration and infiltration - other side.

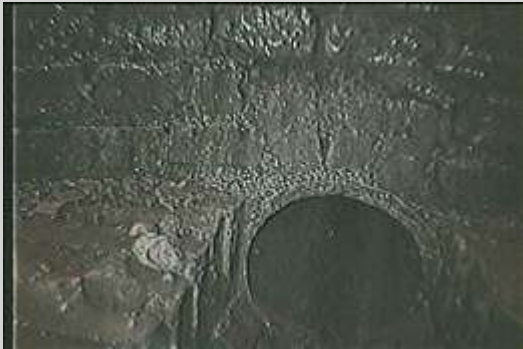
8 in. Circular Gravity Sewer Pipe Out @ 12 O'Clock

Infiltration: **None** Pipe Seal Cond: **Unknown**

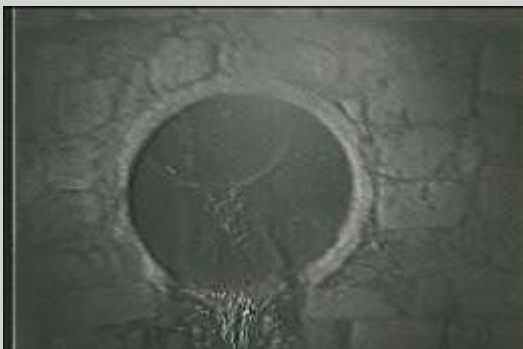
8 in. Circular Gravity Sewer Pipe In @ 3 O'Clock

Infiltration: **None** Pipe Seal Cond: **Cracked**

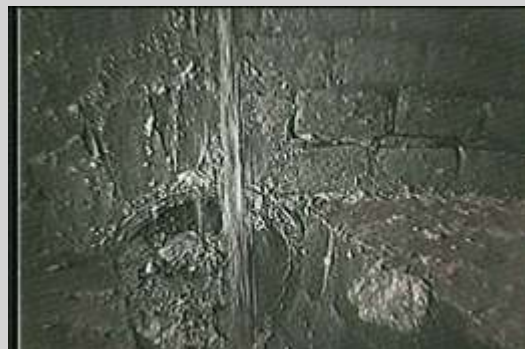
Drop In @ 3 O'Clock

Barrel deterioration and infiltration.

Drop Condition: **Partly Clogged**

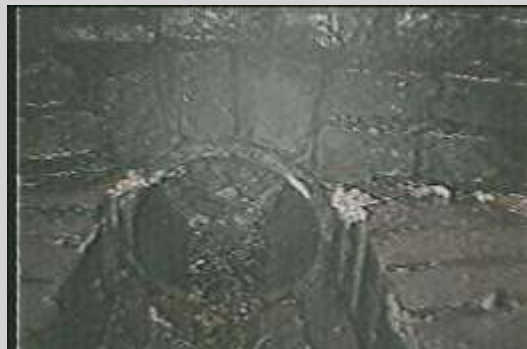
Pipe In @ 6 O'Clock

Barrel deterioration and infiltration. Channel deterioration.
